INDOOR ENVIRONMENTAL SCREENING

**MILLSTONE TOWNSHIP PRIMARY SCHOOL
MILLSTONE TOWNSHIP ELEMENTARY SCHOOL
MILLSTONE TOWNSHIP MIDDLE SCHOOL**

September 3, 2021

PROJECT NO. 21538.00

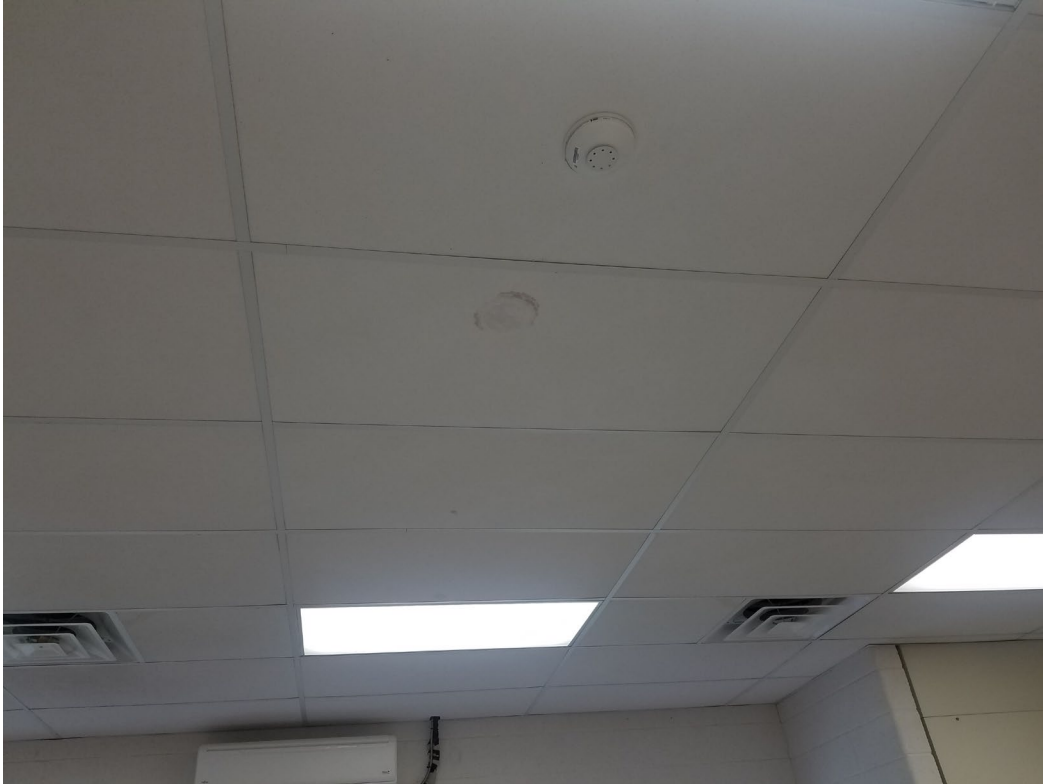
- Most of the ceiling tile staining was limited to small, dried staining of single tiles. The stained ceiling tiles are likely related to small isolated roof or flashing leaks, or condensation on mechanical components. The conditions as observed do not present an elevated risk of negative impacts on IAQ and should not affect building occupancy.

#1 – Staining on acoustical ceiling tiles (typical conditions).

- Stained ceiling tiles should be replaced. A log should be maintained as to the location of the stained tiles. Periodic checks of the affected locations should be performed and tiles replaced as needed until the source can be identified and corrected.

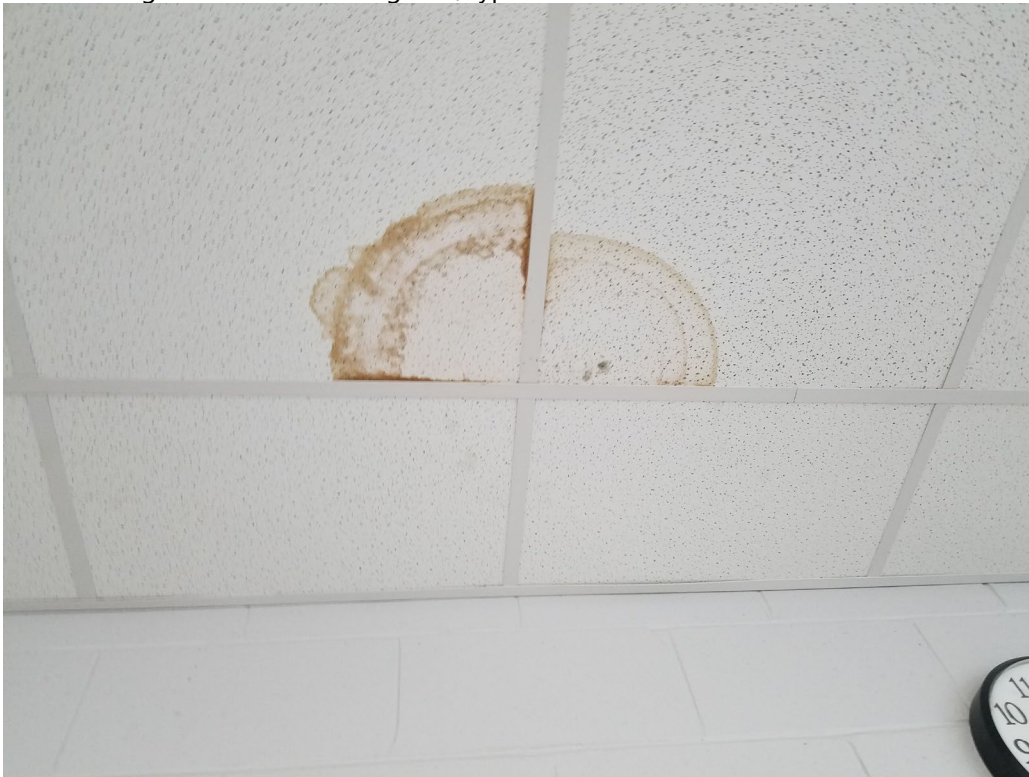
#2 – Staining on acoustical ceiling tiles, typical conditions.
